Fracture analysis of chilled cast iron camshaft

Franz Thomas

Abstract:

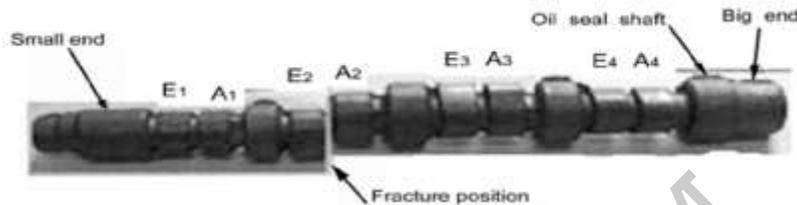
The fractured camshaft is shown in Fig.1. From Fig.1, it is found that the fracture had taken place in the journal region between exhaust cam and admission cam of the 2nd cylinder in the engine. Adherent fins at the molding parting of the fractured camshaft was not thoroughly trimmed, yet, as shown in Fig.2. In addition, there was obvious extruded trace on the interior wall surface of camshaft hole of cylinder head. White macroscopical section of the fracture zone shown in Fig.3 is significantly different from the camshaft from France shown in Fig 4

Fig.1 The photograph of the fracture camshaft

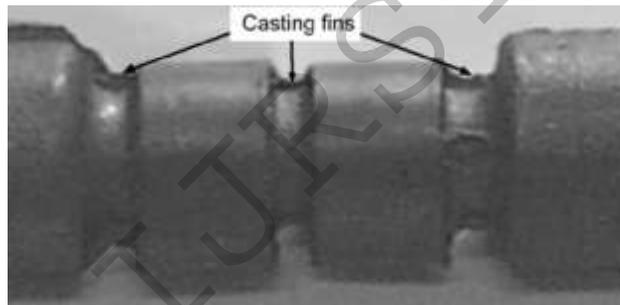
Fig.2 Casting fins at the molding parting

- (b) Purify the melt iron to remove inclusion, and improve gating and riser system to prevent shrinkage defect and so on.
- (c) Prevent the crack from initiation by carefully trimming adherent fins at the parting line of camshaft and avoid hard particle enter into the engine.

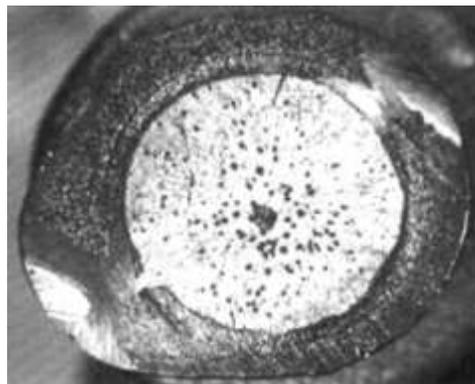
Fig.3 Macroscopical fracture section of the failed camshaft

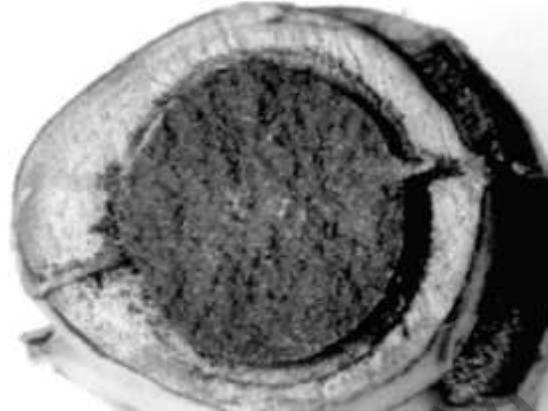
Fig.4 Macroscopical fracture section of the camshaft made by Citroen Company in France

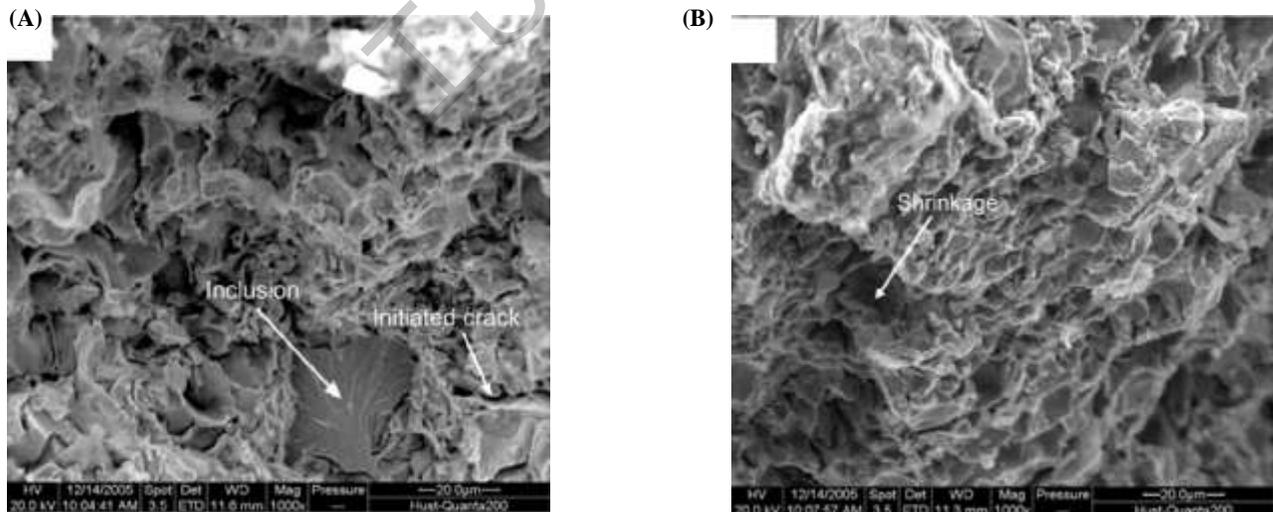
SEM image of fracture section of the failure camshaft is shown in Fig.5. From Fig.5, we can find the casting defects such as dendritic shrinkage and accumulated inclusion, together with initiated crack. The characteristics of the fracture section indicate the mechanism of brittle fracture of the camshaft material.

Fig.6 SEM images of fracture section of the camshaft

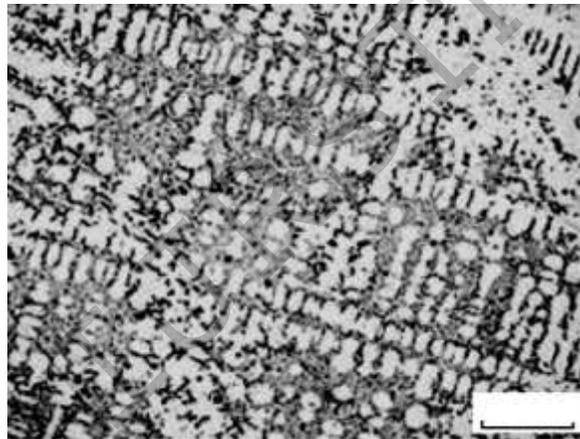
The specimens for the metallographic investigation were taken from the fractured zone of the failed camshaft and the corresponding position of the camshaft imported from France. The results are shown in Figs.6 –9, respectively. Graphitization degree of the fractured zone of the failed camshaft showed very slight, only a few D-type graphite and coarse Ledeburite were found in Fig.6 and Fig.7, respectively. The microstructure was out of specification required by the material standard of

Fig.8 Graphite shape of the corresponding zone of CKD camshaft from France

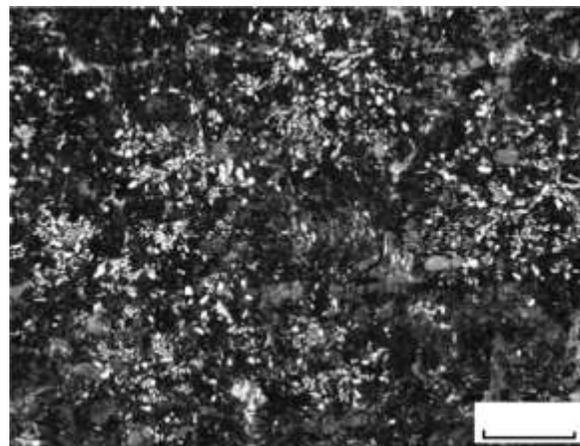
PSA group of France, as shown in Table 1 and Figs.8 and 9

Fig 9. Matrix structure of the corresponding Zone of CKD Camshaft from France
